NASA Technical Paper 1322

Low-Cycle Fatigue of
Thermal-Barrier Coatings
at 982° C

Albert Kaufman, Curt H. Liebert,
and Alfred J. Nachtigall

**Albert Kaufman, Curt H. Liebert,
and Alfred J. Nachtigall**
*Lewis Research Center
Cleveland, Ohio*

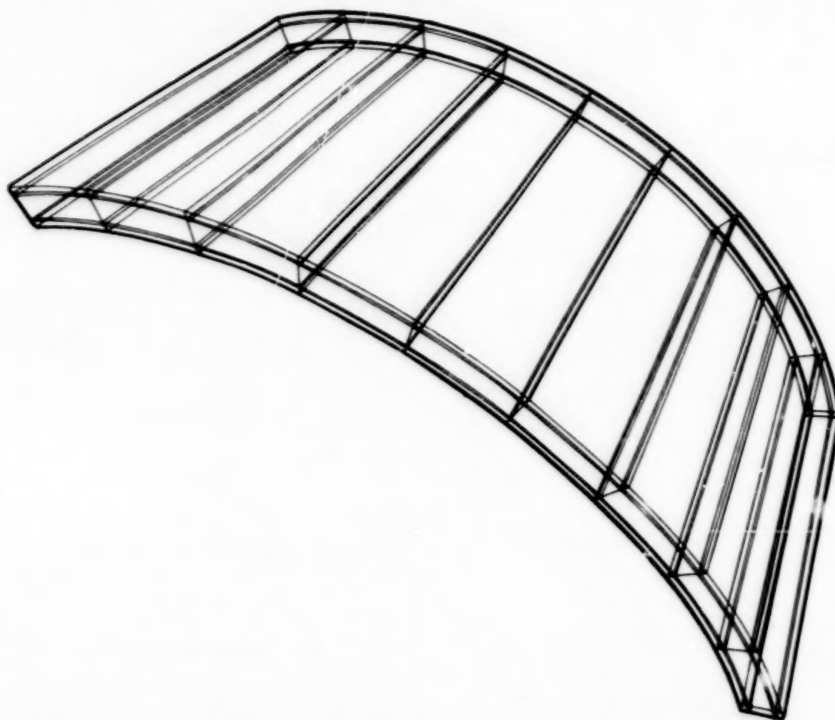
Figure 3. - Finite-element modeling for stress analysis of symmetrical half of coated flexure specimen.

Stress and strain distributions and end displacements for the flexural specimens under various applied mechanical loads were calculated using the MARC nonlinear, finite-element, structural analysis program. The program capabilities, which include plasticity, are described in reference 5. Computations are based on incremental plasticity theory using the von Mises yield criterion (ref. 6). Three-dimensional, 20-node isoparametric elements were used to model the specimens. A three-dimensional model of a coated specimen with a two-layer coating system on each surface of the base metal is shown in figure 3; since this specimen is symmetrical about its midcenter, only half the specimen (an arc of a quarter of a circle) had to be analyzed.

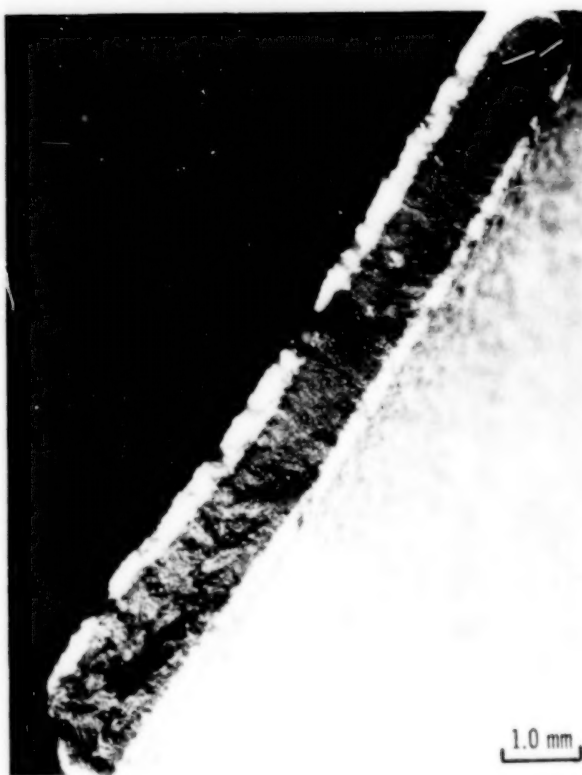
(c) NiCrAlY + ZrO_2 coated TAZ-8A.

(d) NiCrAlY + ZrO_2 + Al_2O_3 coated TAZ-8A.

Figure 7. - Photographs of fracture surfaces of flexural fatigue specimens tested at 982°C in air. (Arrows indicate crack initiation sites.)

The photographs of the fracture surfaces of the two-layer ($\text{NiCrAlY}+\text{ZrO}_2$) and the three-layer ($\text{NiCrAlY}+\text{ZrO}_2+\text{Al}_2\text{O}_3$) coated specimens (figs 7(c) and (d), respectively) show that the coating thicknesses around the specimen surfaces were significantly non-uniform and that transgranular fatigue failure tended to start from the side that had the thickest ceramic coating. Failure in the two-layer coated specimen (fig. 7(c)) was initiated on the concave surface at the edge where chipping occurred (upper right corner). Failure in the three-layer coated system (fig. 7(d)) was initiated at several sites along the convex surface where the ceramic layer was thickest. Both the two- and three-layer coating systems exhibited substantial oxidation of the NiCrAlY layer, as can be seen in figures 8(c) and (d).

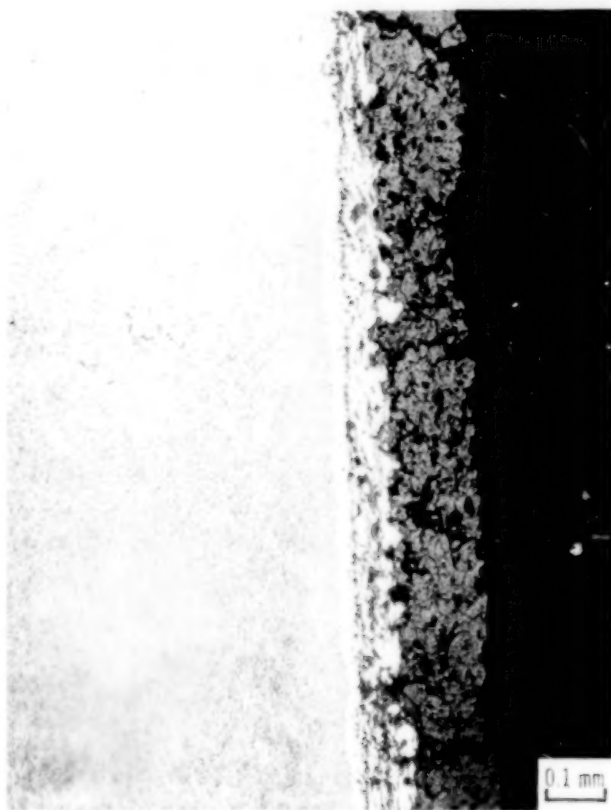
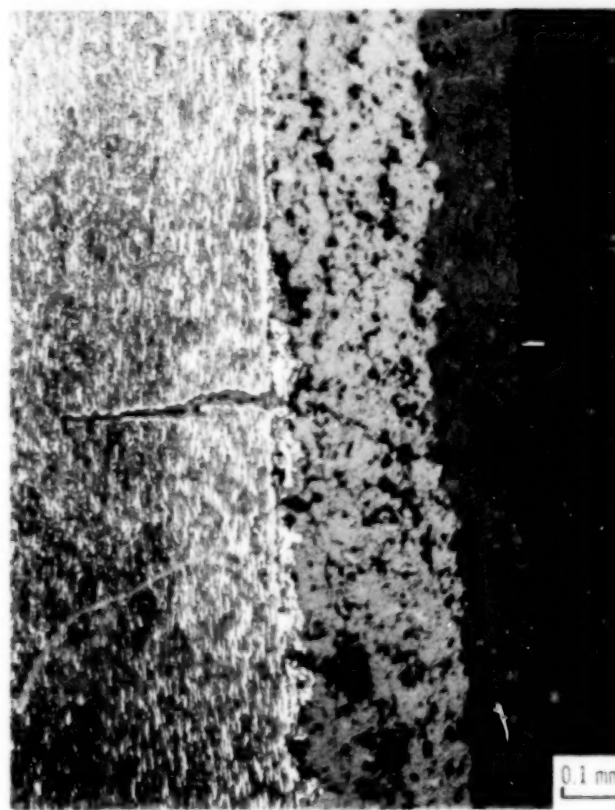
(c) NiCrAlY + ZrO₂ coated TAZ-8A.

(d) NiCrAlY + ZrO₂ + Al₂O₃ coated TAZ-8A.

Figure 8. - Photomicrographs of edges of flexural fatigue specimens tested at 982°C in air.
